DON'T WASTE YOUR TIME FLUSHING PARALLEL FLOW CONDENSERS

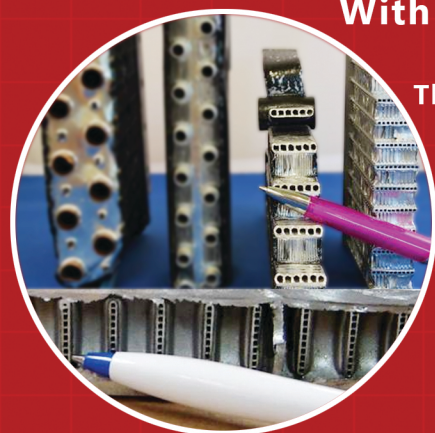
The passages in this type of condenser are the size of a pin head.

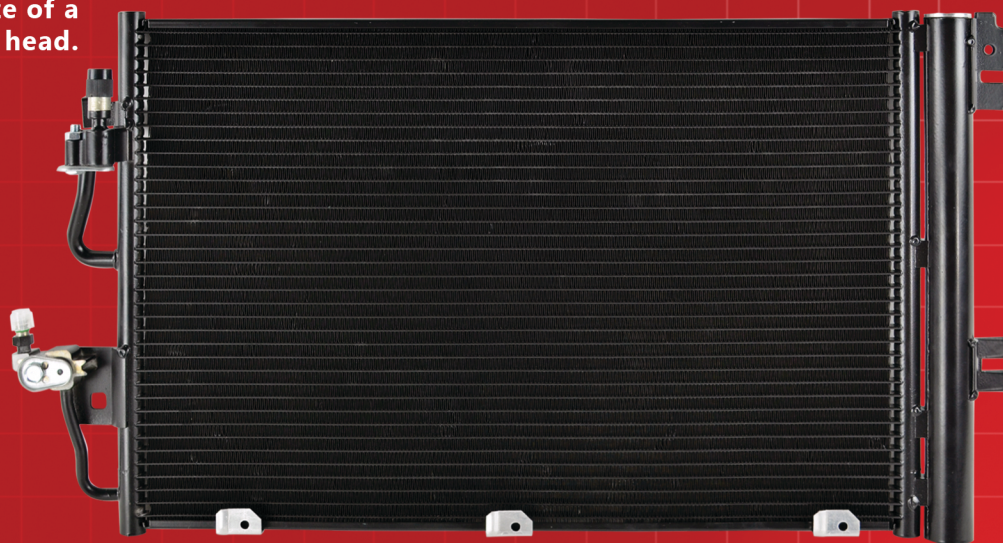
It is impossible to push debris through these passages so flushing will not work – period!

THE CONDENSER MUST BE REPLACED.

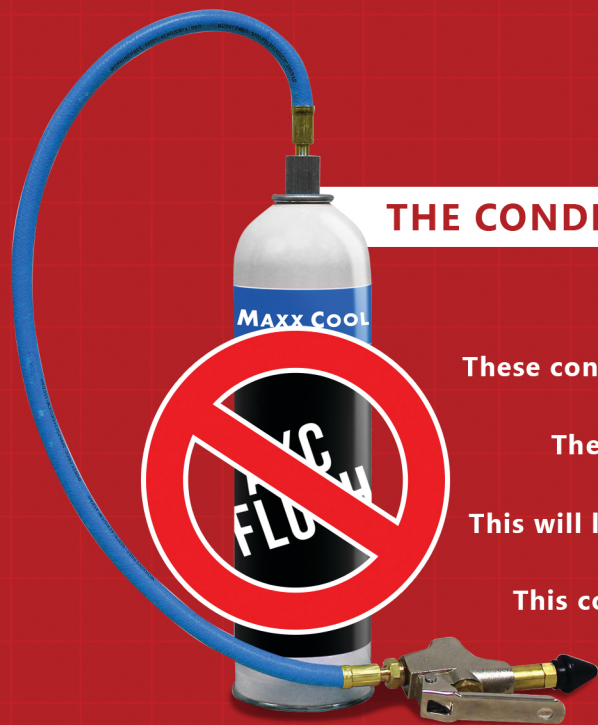
The small openings in a parallel flow condenser will trap this debris.

This will lead to a reduction in the amount of rows to cool the refrigerant.

This could also lead to high head pressure in the compressor and could cause the compressor to fail.

**THE COST OF A NEW CONDENSOR IS A LOT LESS THAN
A NEW COMPRESSOR – WHY TAKE A CHANCE?**
